HISTORIC PRESERVATION CERTIFICATION APPLICATION
REQUEST FOR CERTIFICATION OF COMPLETED WORK

1. Name of property: Burgess Carriage House (Burgess Estate Complex)

Historic Pres. Certification Applic.
8450 Main Street, Ellicott City, MD
North and East Elevations--
Before/After

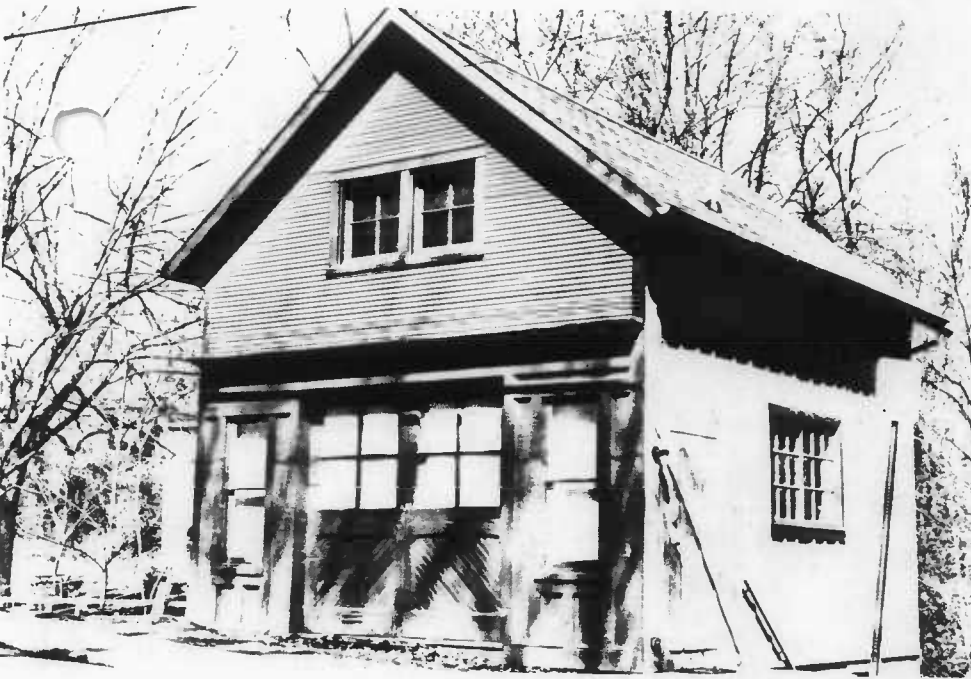
Fig. C-1 Front facade restored using all existing material. Windows and carriage doors repaired. Right side elevation shows new sliding wooden sash with true divided lights to match original plus new "concealed" door used as main entrance. All siding existed pre-rehab.

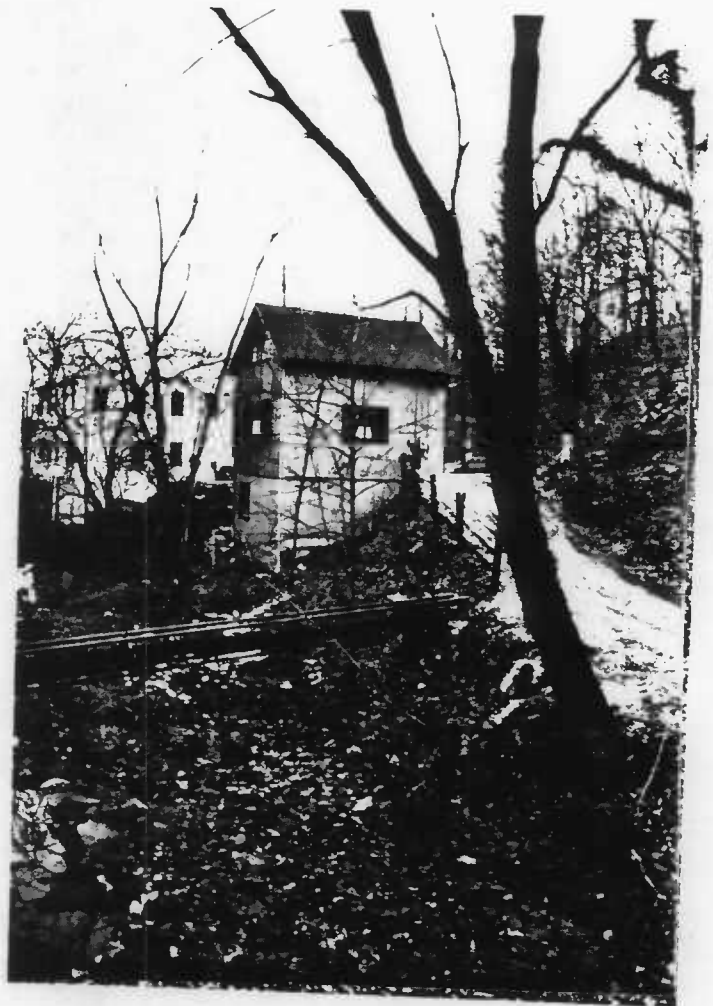
Fig. C-2 Left and rear side elevations after rehabilitation. Left elevation has replicated sliding wooden sash to match what existed originally. On rear, new window installed at basement level; heat pump shown in first floor window; and single window in attic converted to pair unit

All siding existed pre-rehab. No other changes to rear or left side elevation. Driveway upgraded slightly; otherwise no site change (new gravel at entrance and a little widening).

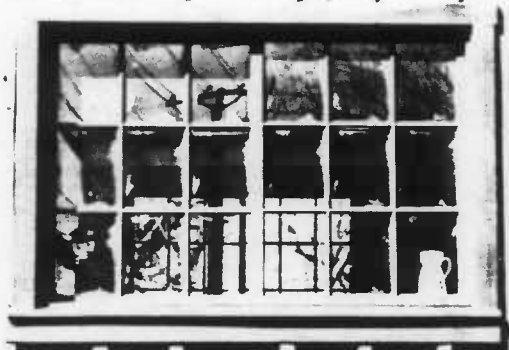
Fig. C-3 Replicated sliding wooden sash installed in original openings on side elevations. Windows are single glazed with true divided lights

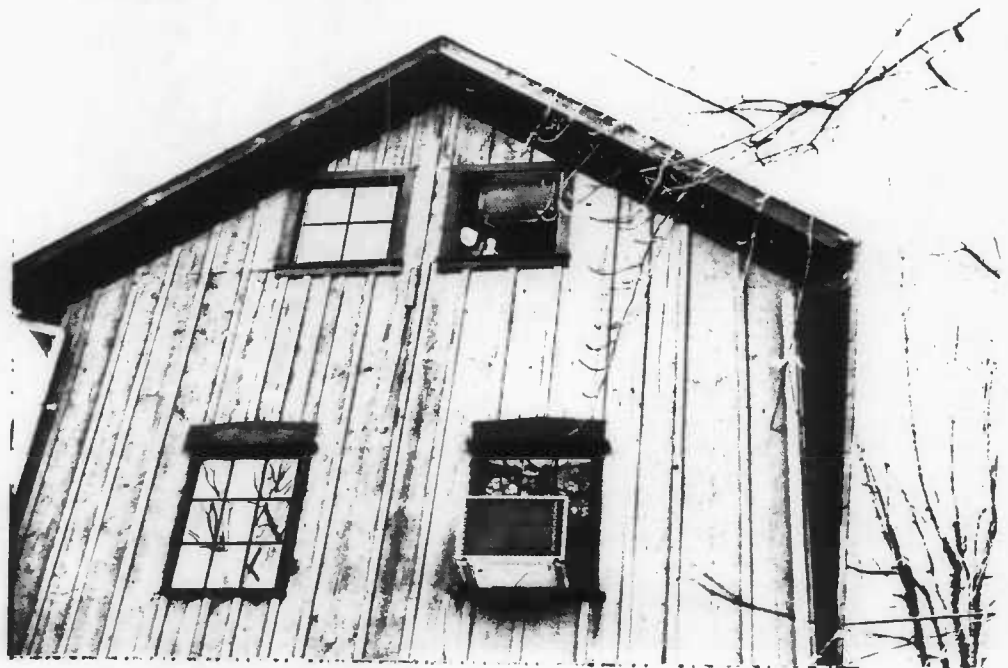
Fig. C-6 Rear elevation after rehab. Windows on first floor retained; board and batten retained. Window in attic converted from single 4-light opening to a split paired unit. Heat pump window units placed in 2 right windows to avoid cuts thru wall.

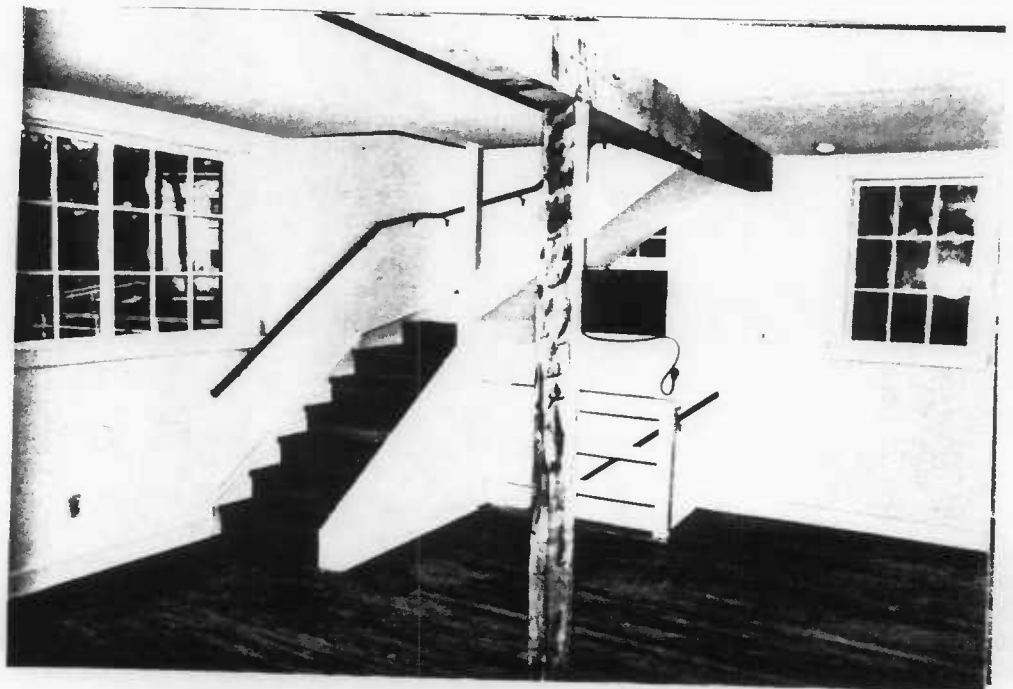
Fig. C-8 Rear and left side wall of first floor after rehab. New stairs installed in left rear to replace ladder to attic. Stair also goes to basement which previously could be reached only by outside door. Rear sash restored; sliding sash replicated.

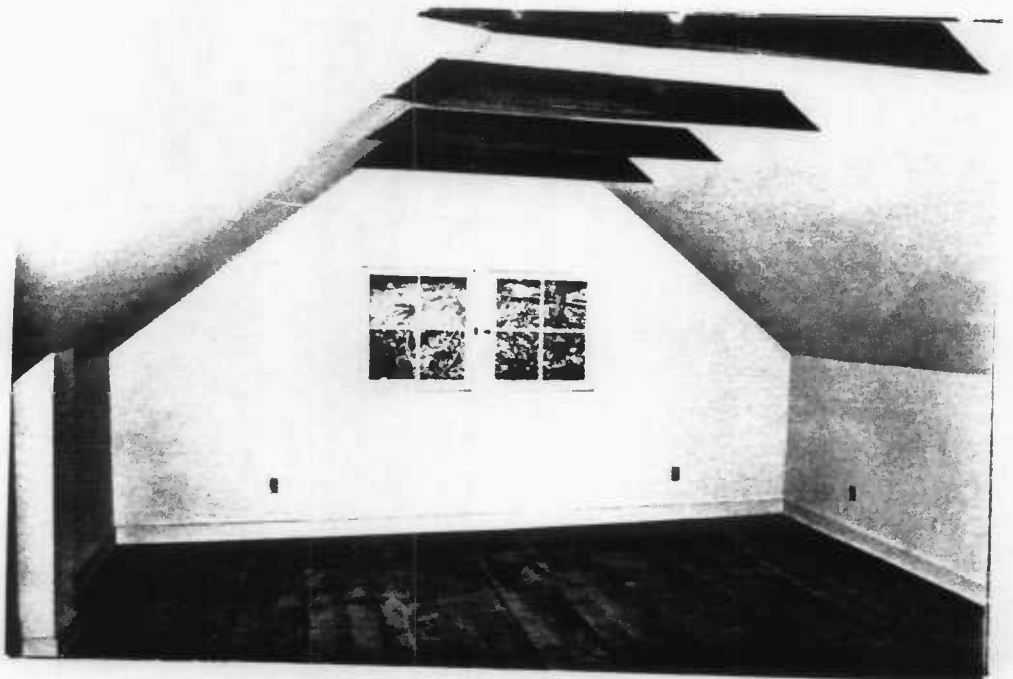
Fig. C-10 Carriage house attic showing restored floor and front windows and new drywall. Exposed beams are original structural system.

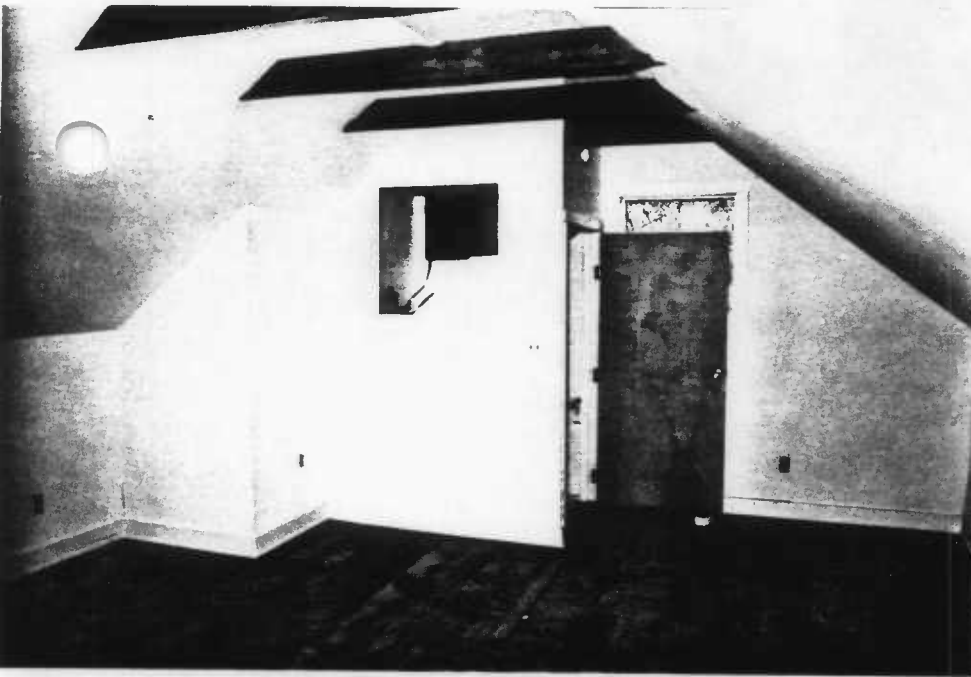
Fig. C-11 Rear of rehab. attic of carriage house. Modification to rear window required for code purposed.

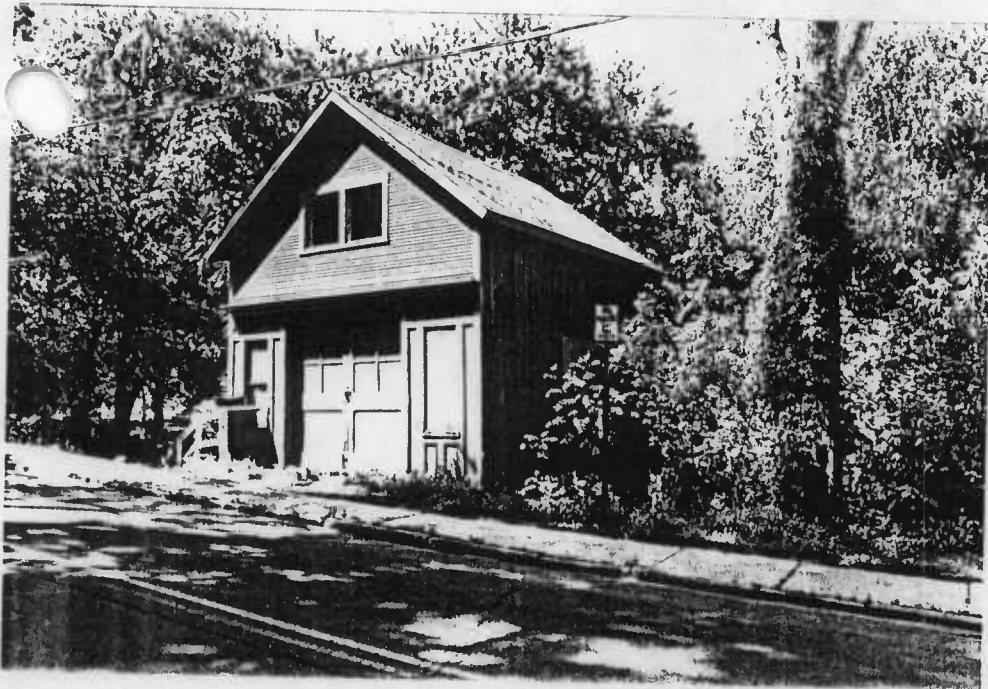
Fig 1.
Main Street facade of
Burgess Carriage House

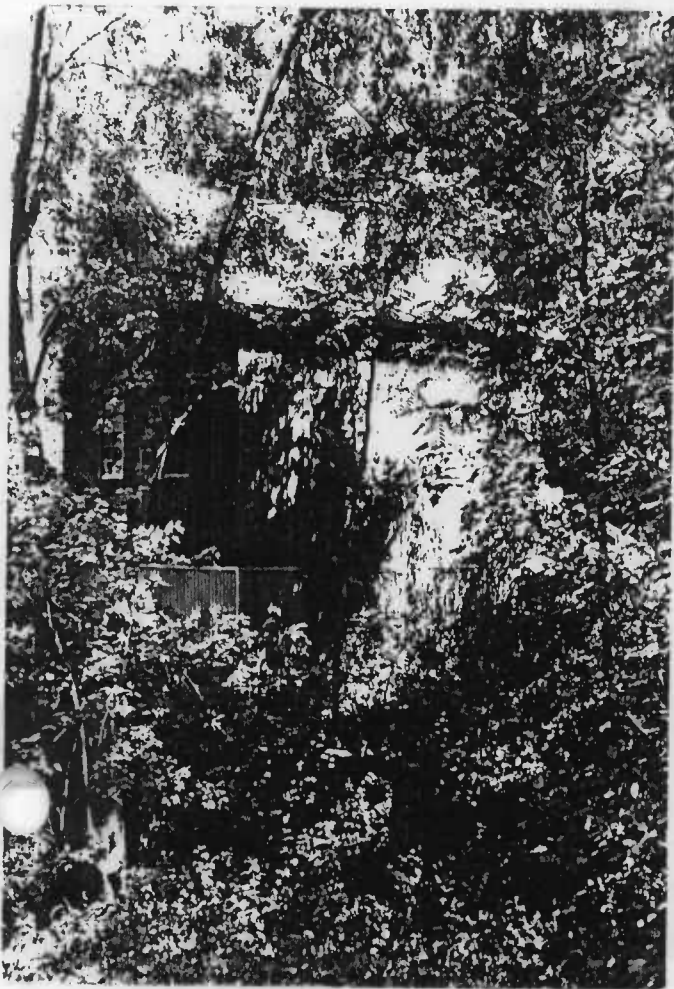
Fig 2.
Rear and side elevation of
Burgess Carriage House
